North Shore Marine Terminal – Dock Damage from LCS 21 Docking operation.

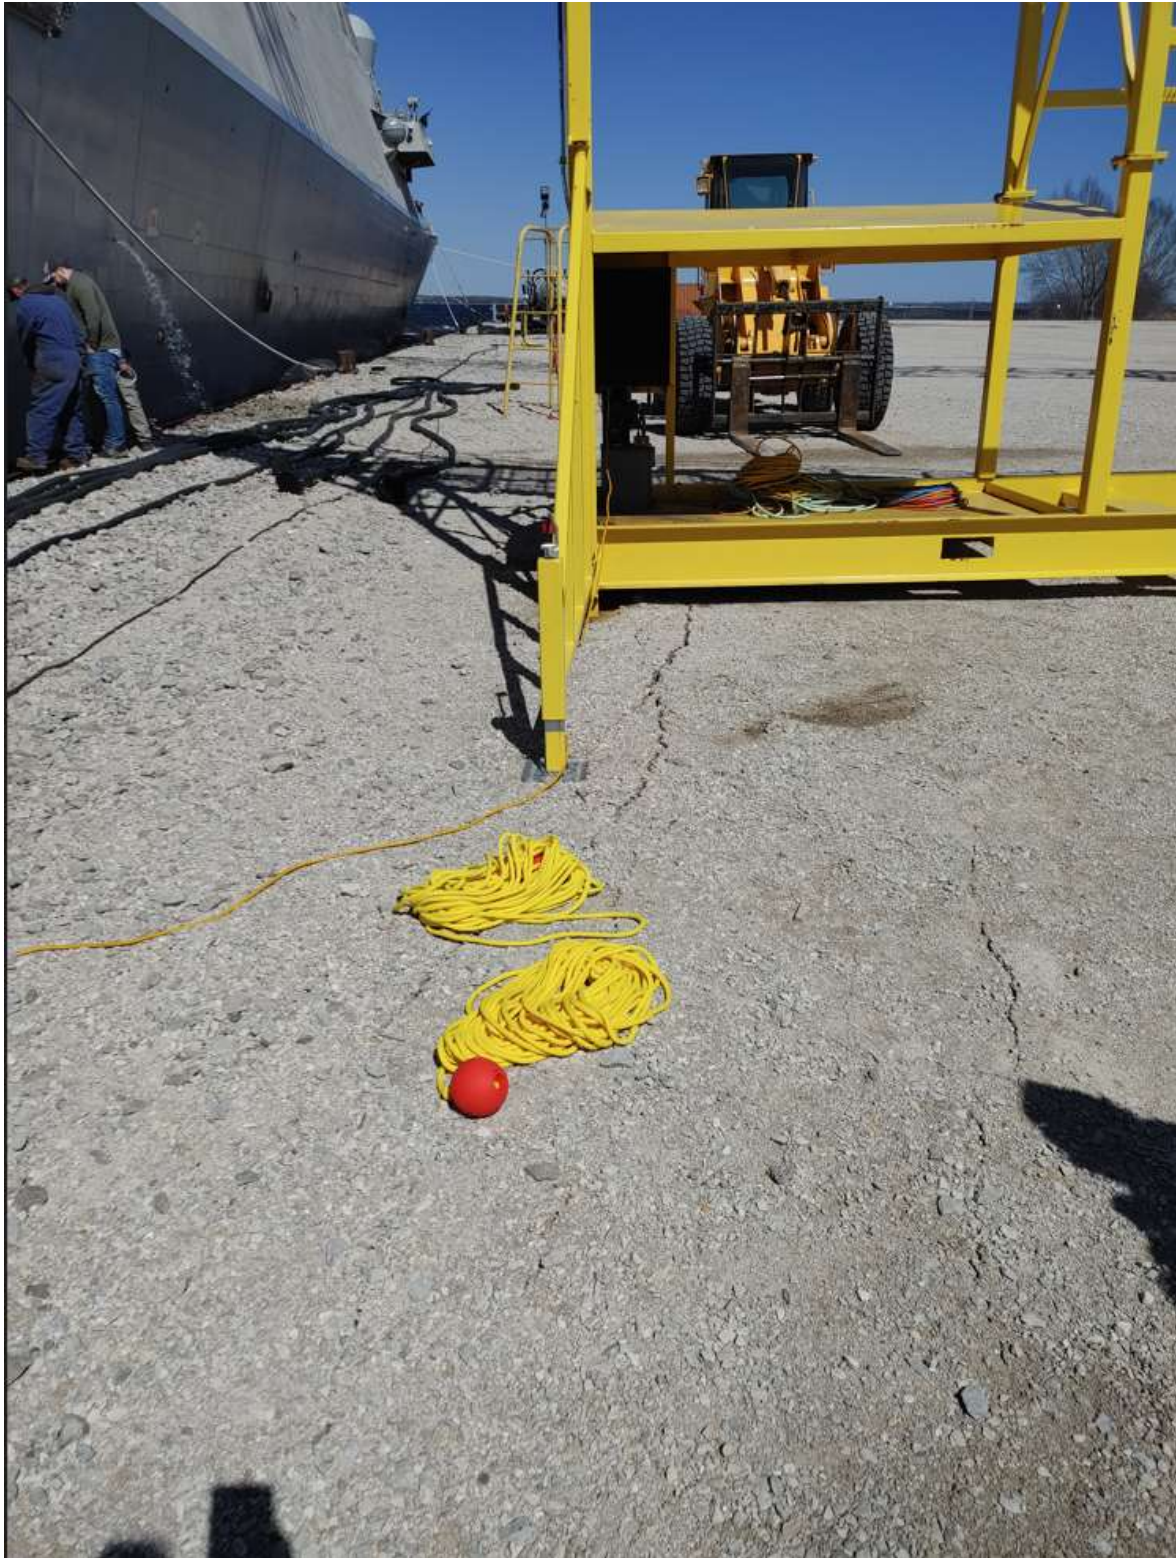
Ground Cracks – View 2

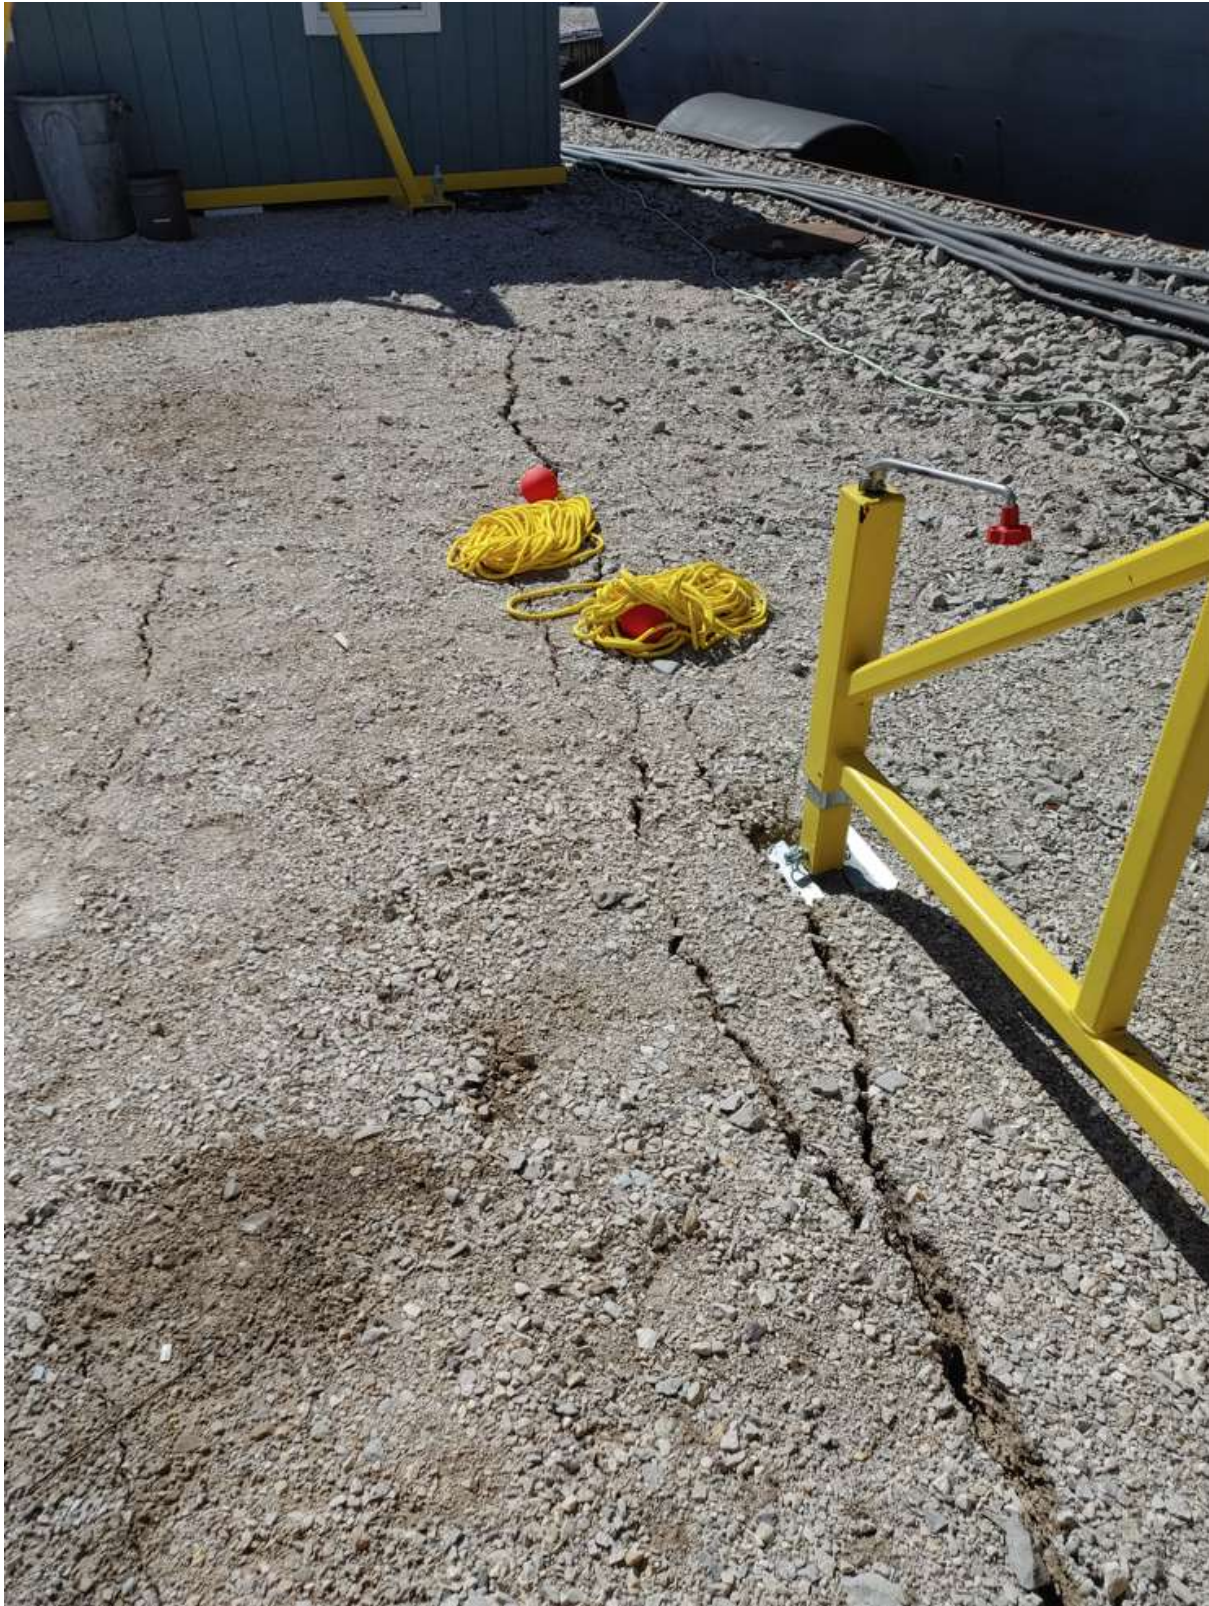
Ground Cracks – View 3
